THE EFFECT OF TOP OF RAIL FRICTION CONTROL ON A EUROPEAN PASSENGER SYSTEM: THE HEATHROW EXPRESS EXPERIENCE

Mark Chestney*, Nass Dadkah[‡] and Don Eadie[#],

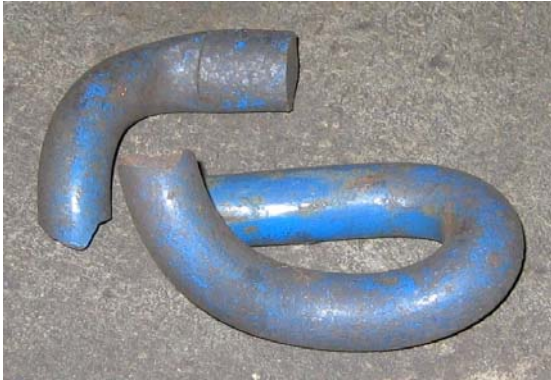
Figure 1 Example of typical broken clip

Clip breakage had become a serious issue for Heathrow Express, particularly in the tunnel areas. The track structure is rather stiff and non resilient. Concrete sleepers are used on Pandrol studded rubber pads with concrete slab track. The clip type used is Pandrol e-clip 2000 series. Alternative e-plus clips were considered but replacement of existing clips was considered impractical. The failure mechanism of the clips is believed to be through fatigue, induced by high lateral deflections of the rail foot. The high deflections in turn are a result of the fundamental problem, high lateral forces on the rail. Figure 1 shows a typical example of clip failure.

Clip breakage of the type shown in Figure 1 is likely due to fatigue induced by a large number of lateral deflections exceeding the threshold for the clip. It was anticipated that if TOR friction control reduced lateral forces, that this in turn would reduce clip deflection and fatigue failure. Given that the population of clips at the start of the trial will have experienced a range of deflections depending on both their location in the track (lateral forces / deflection experienced) and the length of time the clip had been in track, it might be expected that the effect of reduced lateral forces on clip breakage might be gradual.

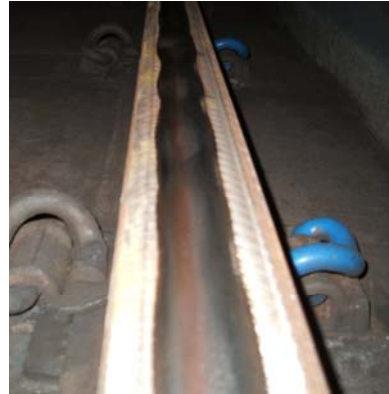
Typical low rail corrugations between CTA and T4 are shown in Figure 2 below. The Corrugation Analysis Trolley (CAT) profile of a typical corrugated section is

Figure 2 Typical low rail corrugations between CTA and T4

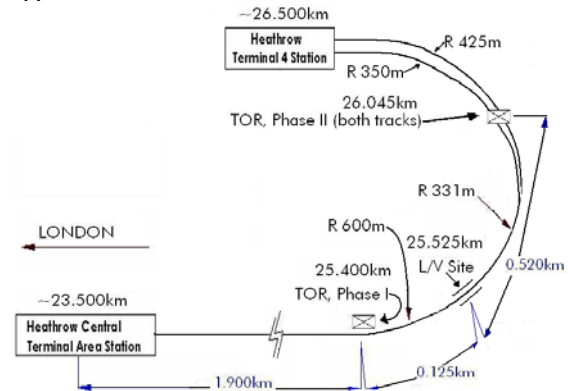
Figure 4 Schematic of test area from CTA to Terminal 4

Figure 4 shows a schematic of the test area between CTA and T4. In this section trains run bi-directionally, inbound and outbound from T4. Normal guidelines for application of FM in bi-directional traffic are for wayside application at each end of the track to be treated. It was decided to initially install just one wayside applicator, referred to the “Phase I” unit, in the location shown in Figure 4. This unit will apply FM to trains inbound to T4 and outbound to CTA. However when only this unit is operational trains outbound from T4 will not be treated until they pass this application unit, heading out of the test area. The intention with Phase I was to gain experience of TOR, establish safe operation, and gather initial results. Phase II was to add a second unit at T4 to treat trains outbound from T4. Guidelines for installation of TOR applicators specify that the applicator should be installed in tangent track at least 30m from the start of the spiral¹⁴. For the Phase I unit practical issues related to site access / space precluded this, and the unit was installed at one end of a 600 m radius curve. In practice this location did not pose any major application issues.

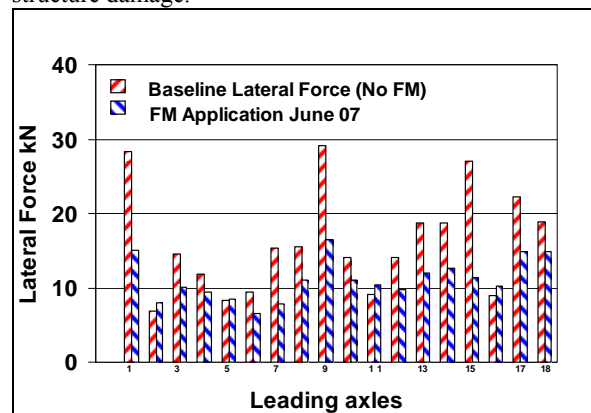
Further analysis of lateral forces on an axle by axle basis (Figure 6) indicated that the individual axles with the highest base line lateral forces (leading axles on driving cars) showed a much higher reduction in lateral forces (40-50%). These will be the wheels leading to the greatest rail deflection and causing the most track structure damage.

Figure 6 Leading Axle by Axle comparison inbound Class 332 trains, Phase I application versus baseline

Whereas with FM application the lateral forces on the low rail were consistent, the high rail forces showed oscillations between negative and positive values. This suggests that the leading wheels are not in saturated lateral creepage, but that the leading high rail wheels are oscillating on and off flange. Absolute force values were used to determine average values. It is hypothesized that the large difference in lateral forces between inbound and outbound trains is because braking

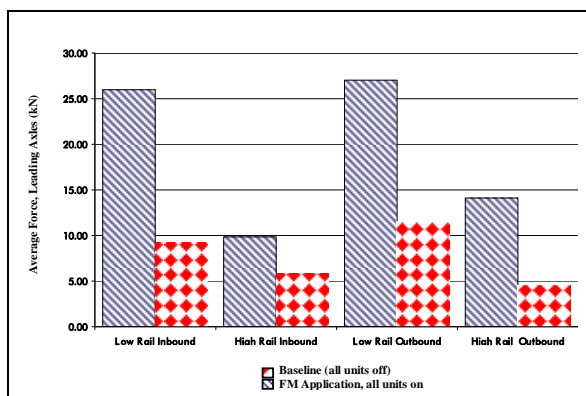
Figure 8 summarizes the lateral forces for Phase II results, comparing baseline forces (Class 360 trains), for inbound and outbound trains with application from both the Phase I and Phase II units. Comparison with Figure 5 clearly shows the much greater lateral force reduction with application of FM from both ends of the test zone. This optimized arrangement has become the standard on-going configuration. The results indicate that average lateral force reductions of $\geq 50\%$ resulted from application of TOR FM under these conditions.

Figure 8 Average leading axle lateral forces, with and without FM (Phase I and Phase II units operating), Class 360 vehicles

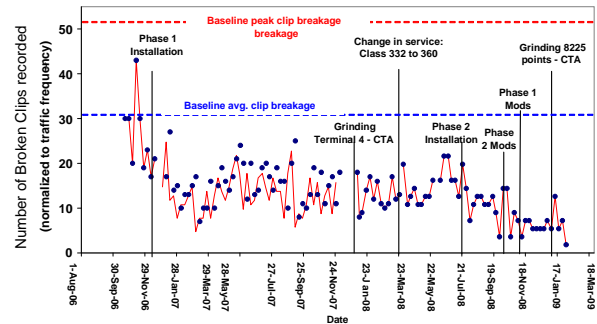
Clip breakage was monitored by routine reports from Network Rail (NR) inspectors. A more intensive clip breakage monitoring program over a limited test area was also carried out during Phase I. The NR results shown in Figure 9 illustrate the whole trial period. The clip breakage data has been normalized to account for the change in traffic pattern with the opening of Terminal 5 (reduced number of axles per day).

Figure 9 Clip breakage rate (adjusted for traffic frequency)

The intensive monitoring showed a reduction in clip breakage within the first few weeks of the start of Phase I, declining from an average of about 30 per week to about 10- 20. The more intensive monitoring also showed that after FM, clip breakages were primarily in locations at the T4 end (further from the Phase I applicator).

Through the course of Phase 1, clip breakage rates continued at a much reduced rate. For two weeks in the middle of February 2007, the application was inadvertently stopped, as the unit had not been refilled with FM. A second two week interruption occurred in mid May 2007 due to an inadvertently disconnected wheel sensor cable. An increase in clip breakage was noted in this period, peaking at about 25 in early June. Once stable application was re-established, the clip breakage rate returned to an average of about 15 per week until the start of Phase II.

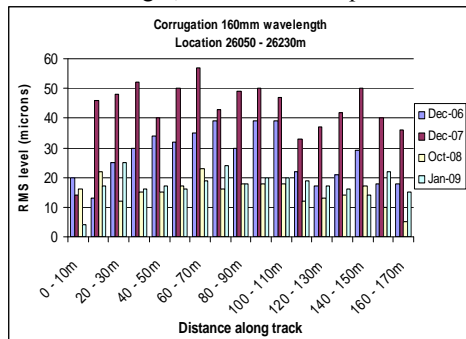
Figure 10 shows the results of corrugation monitoring (160 mm wavelength) at the specified location, from December 2006. All measurements except October 2008 were taken a few weeks prior to the next scheduled grind. Essentially identical results were obtained for 125 mm wavelength, which are not reproduced here.

Figure 10 RMS Corrugation amplitude (160mm Wavelength) at 26050-26230m before and after FM application

From the data in Figure 10, average corrugation growth rates in microns per month can be calculated, and are shown in Table 1. The data has been normalized in the same way as the clip breakage data to take into account the change in traffic pattern after the opening of Terminal 5 (44% axle reduction). The calculations assume a linear increase in corrugation amplitude with time after grinding, which may be questionable. These factors do not change the overall conclusion.

The data shows that at the monitoring point 0.7 km from the Phase I unit, the corrugation growth rate was reduced by about 45% compared to the baseline (pre-FM period) with Phase I operation only. With the addition of the Phase II unit, corrugation growth rate further decreased. Although only a three month period has been measured so far when both Phase I and Phase II units have been fully operational, this shows a growth rate reduced to 1.11 microns per month, an 81% reduction from the baseline period. This result is somewhat lower than the 8-12 fold reductions recorded previously on European and Japanese metro systems⁸, but still a significant improvement from a practical maintenance standpoint.
