CASE STUDY

**TOTAL**TRACK MONITORING

## **L.B. Foster Rockfall Monitoring**

Safer and More Cost-Effective than Traditional Slide Fences

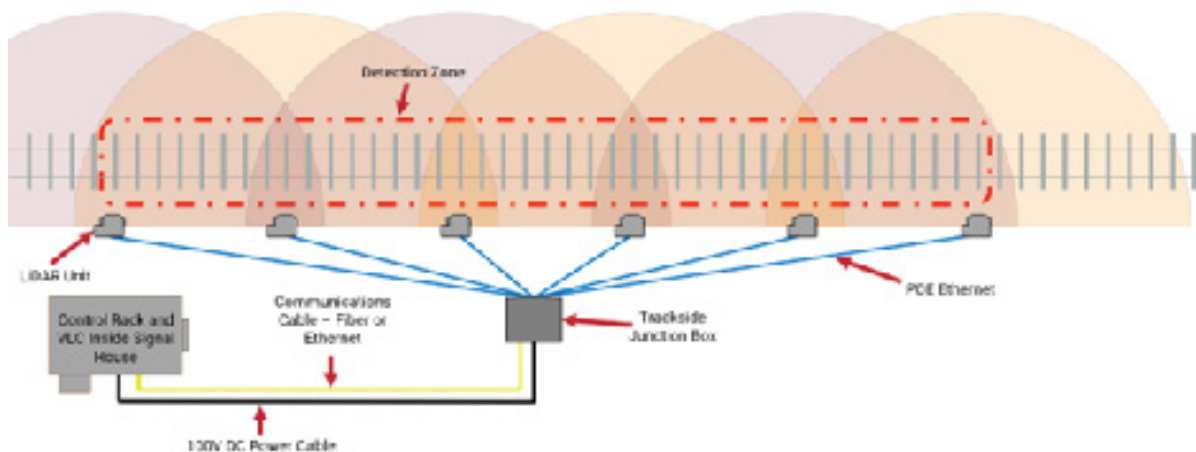
- > **Local System Configuration:** The addition of an HMI screen within the control rack was made to allow for on-site system information. This includes system status, needed maintenance activities, alarm logging and alarm mapping.

- > **Power Architecture:** Based on customer feedback, we moved to transition the power to DC at a safe voltage. This shift was aimed to reduce installation costs and simplified hardware requirements. Additionally this made power backup much simpler, and electrical work on the system much safer for maintainers.

- > **Cost Efficiency:** Finally the feedback that we received from our customers routinely highlighted a high installation cost. With this feedback in mind, the system was redesigned to require less hardware to be installed. Notably, each LiDAR on previous systems required a junction box. This was reduced to 1 junction box for up to 8 LiDAR units. Additionally, from the junction boxes, the system wiring scheme was improved to utilize POE ethernet with the aim to lower installation costs. These advancements made the system more accessible for rail operators, with reduced installation complexity and lower maintenance demands.

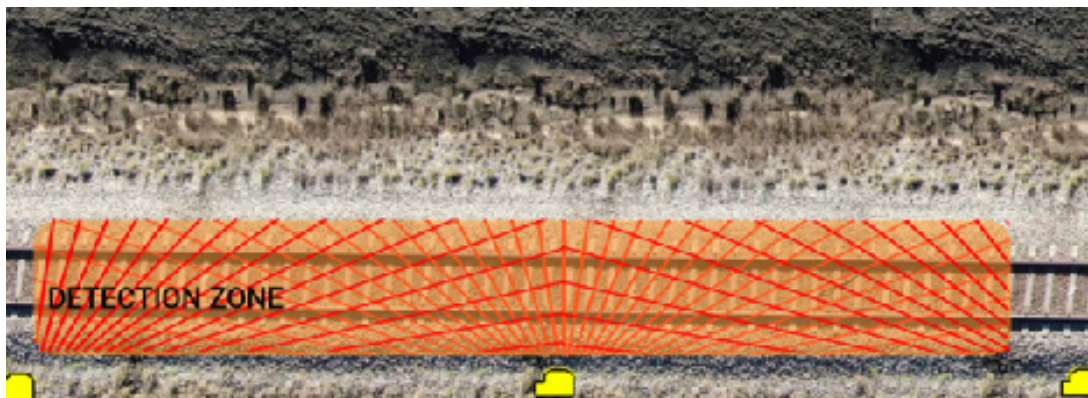
- > 2D LiDAR scanners are strategically placed every 87 feet along the track.
  - > This spacing allows for redundant coverage of the track, and any obstacle is seen by at least 2 LiDAR from 2 angles.
  - > The detection zone spans 6 feet from the track center, ensuring comprehensive coverage of the track.

- > **Obstacle Detection:** If an object is identified within this zone, the system triggers an alarm to signal potential obstructions.

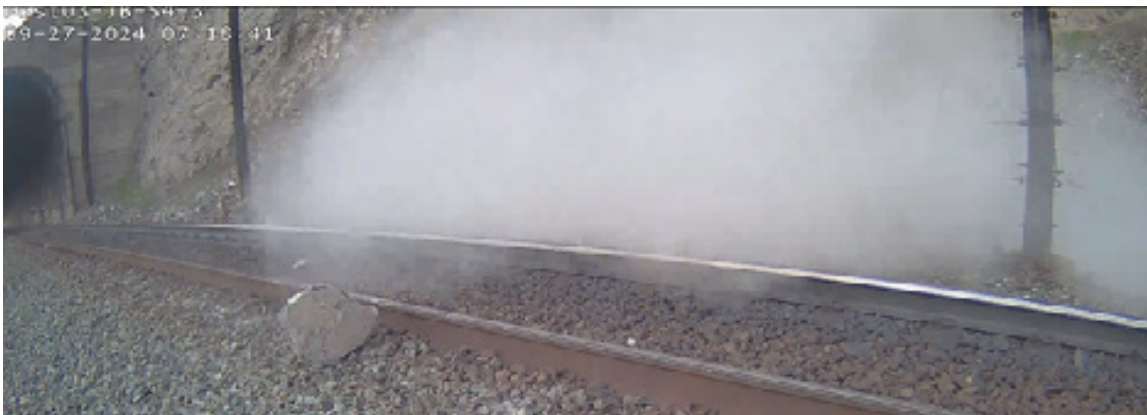
Fig. 1. Qualifying Rockfall Event Captured by Rockfall Monitoring, Missed by Slide Fence

A qualifying rock of approximately 16" X 22" fell within the detection zone at 7:18am on September 27th 2024. Upon video review of the event, this rock bounced through the slide fence wires without tripping the fence. Being of the minimum size that the rockfall system is set to alarm upon (Greater than 16X16), and being within the detection zone, Rockfall Monitoring went into alarm. This alarm set the local relay from clear to obstructed, and sent out an alarm email 45 seconds after the event took place to the customer's personnel.

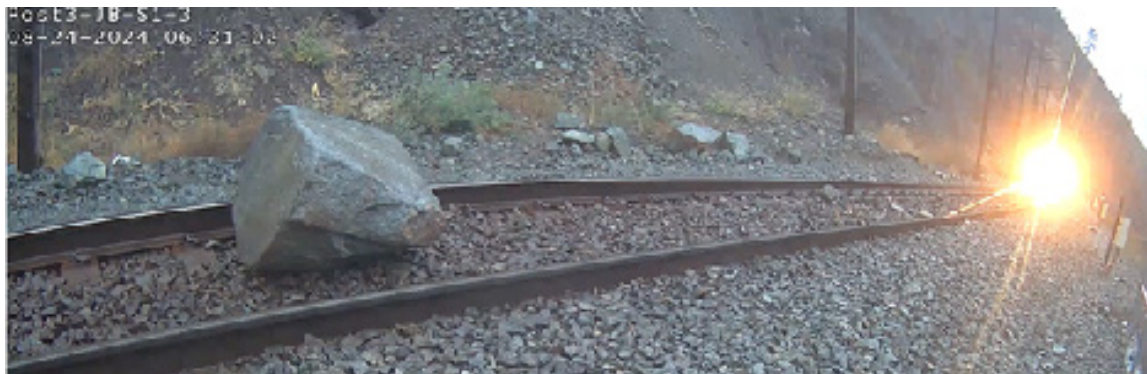
Fig. 2. Train Stopped Short of Rockfall Event Captured by Rockfall Monitoring, Missed by Slide Fence

A qualifying rock of approximately 36" X 44" fell within the detection zone at 2:50am on September 27th, 2024. Upon video review of the event, this rock bounced through the slide fence wires without tripping the fence. The below image shows the bottom wires, where the rock passed through intact. Furthermore, this missed activation was confirmed by the railroad.

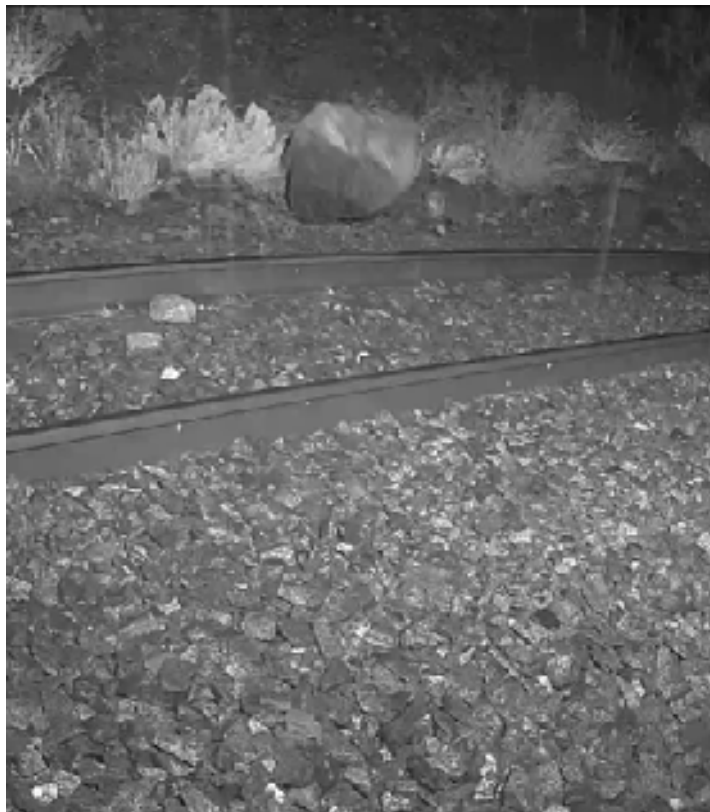
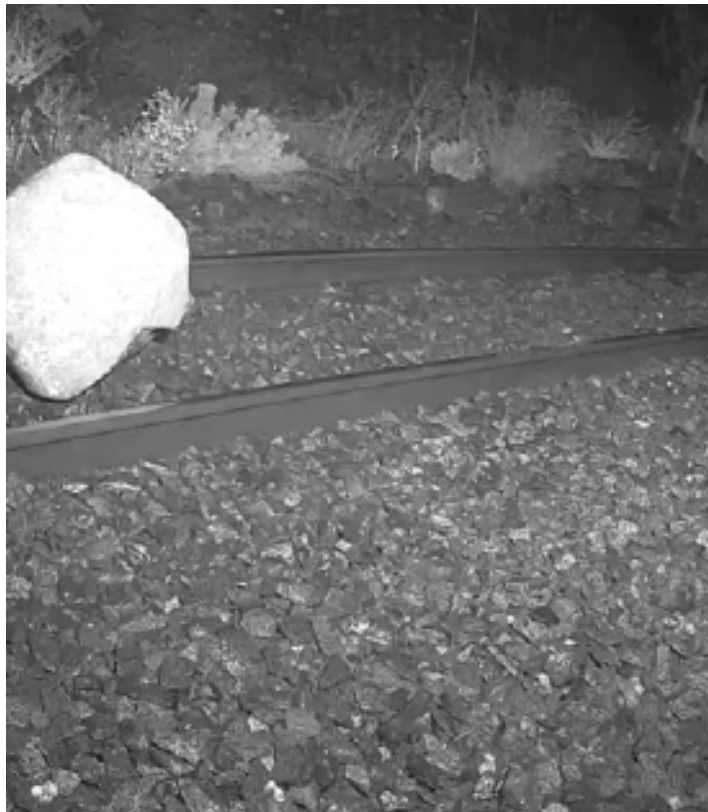
Being of well above the minimum size that the rockfall system is set to alarm upon (Greater than 16X16), and in the center of the detection zone, Rockfall Monitoring went into alarm. This alarm set the local relay from clear to obstructed, and sent out an alarm email 45 seconds after the event took place to the customer's personnel. This alert was used to stop local train traffic and send maintainers out to clear the track. This detection was critical in highlighting the dangers of relying on a slide fence, rather than actively monitoring the tracks for obstructions.

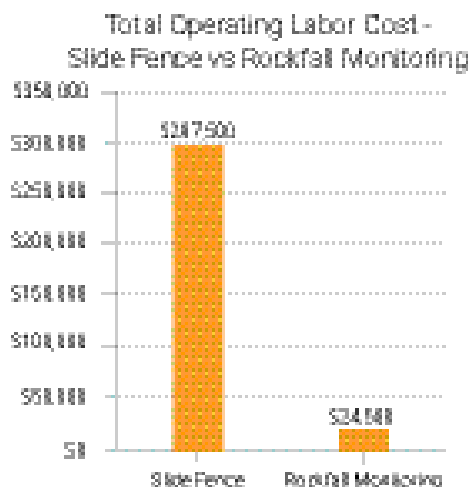
**Cost of Slide Fence Activations (Through 2024)**

When a rock slide fence is activated, the system remains in alarm until the fence is manually reset or repaired. Due to this, any activation, whether genuine or false-alarm requires a maintenance callout. Rockfall Monitoring on the other hand will automatically reset if an alarming obstacle is removed and is much less prone to false alarm than a slide fence from benign environmental conditions. During the trial period the slide fence required 85 callouts to reset the system. During the same period, Rockfall Monitoring only had 5 events for routine maintenance, and 3 valid obstacles needed to be cleared; a total of 7 callouts. For sake of comparison a callout will be assumed to cost approximately \$3,500, a number determined by a 2018 case study around slide fence maintenance. These operational labor cost comparisons for labor are denoted in the chart above.

Moreover, Rockfall Monitoring delivers substantial operational cost savings. During the trial, the slide fence required 85 maintenance callouts, compared to just 7 for Rockfall Monitoring. With each callout costing an estimated \$3,500, the potential for cost reduction is clear. Additionally, Rockfall Monitoring's lower false alarm rate resulted in significantly less train slow order time—129 fewer hours compared to the slide fence—further boosting operational efficiency and reducing service delays.

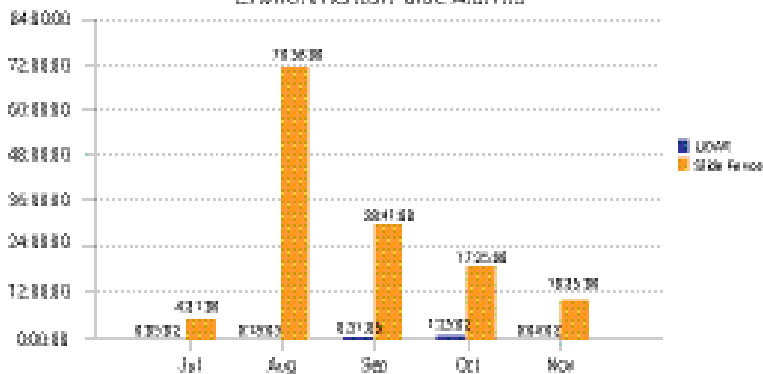
**Slow Order Time (HH:MM:SS) by System Type  
Environmental False Alarms**

Environmental conditions cause the slide fence to routinely false alarm. These false alarms still trigger a slow order as trains need to approach the area at caution. Throughout the trial period, environmental conditions leading to false alarms, and slow orders were meticulously tracked. Through July-November, the slide fence caused 131 hours of slow order time at the site. Through this same period, Rockfall Monitoring resulted in 2 hours of slow order time, a 98.5% reduction from the slide fence.
