CASE STUDY

## **L.B. Foster Rockfall Monitoring**

Safer and More Cost-Effective than Traditional Slide Fences

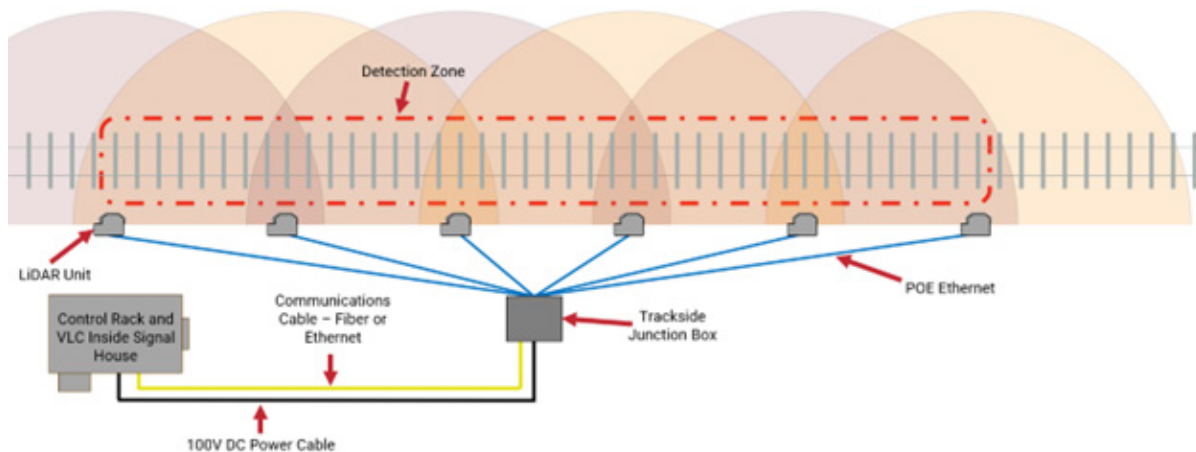
- > **Local System Configuration:** The addition of an HMI screen within the control rack was made to allow for on-site system information. This includes system status, needed maintenance activities, alarm logging and alarm mapping.

- > **Power Architecture:** Based on customer feedback, we moved to transition the power to DC at a safe voltage. This shift was aimed to reduce installation costs and simplified hardware requirements. Additionally this made power backup much simpler, and electrical work on the system much safer for maintainers.

- > **Cost Efficiency:** Finally the feedback that we received from our customers routinely highlighted a high installation cost. With this feedback in mind, the system was redesigned to require less hardware to be installed. Notably, each LiDAR on previous systems required a junction box. This was reduced to 1 junction box for up to 8 LiDAR units. Additionally, from the junction boxes, the system wiring scheme was improved to utilize POE ethernet with the aim to lower installation costs. These advancements made the system more accessible for rail operators, with reduced installation complexity and lower maintenance demands.

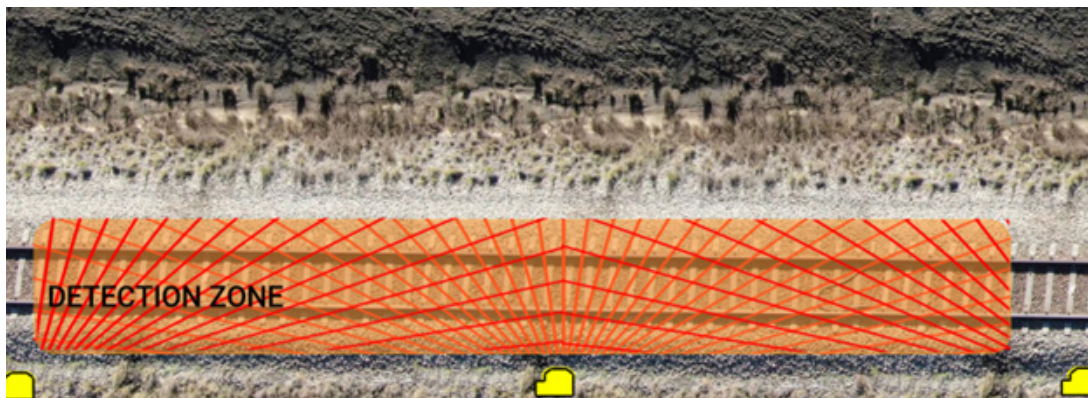
- > 2D LiDAR scanners are strategically placed every 87 feet along the track.
  - > This spacing allows for redundant coverage of the track, and any obstacle is seen by at least 2 LiDAR from 2 angles.
  - > The detection zone spans 6 feet from the track center, ensuring comprehensive coverage of the track.

- > **Obstacle Detection:** If an object is identified within this zone, the system triggers an alarm to signal potential obstructions.

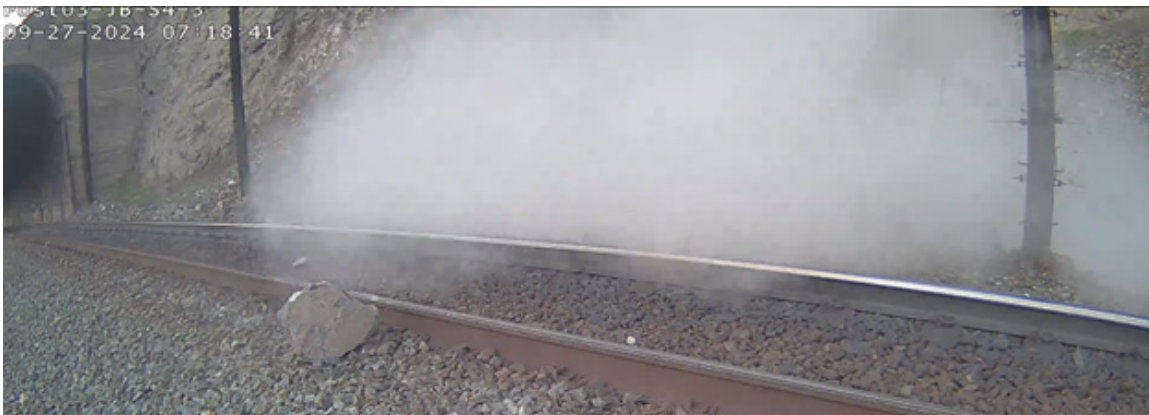
Fig. 1. Qualifying Rockfall Event Captured by Rockfall Monitoring, Missed by Slide Fence

A qualifying rock of approximately 16" X 22" fell within the detection zone at 7:18am on September 27th 2024. Upon video review of the event, this rock bounced through the slide fence wires without tripping the fence. Being of the minimum size that the rockfall system is set to alarm upon (Greater than 16X16), and being within the detection zone, Rockfall Monitoring went into alarm. This alarm set the local relay from clear to obstructed, and sent out an alarm email 45 seconds after the event took place to the customer's personnel.

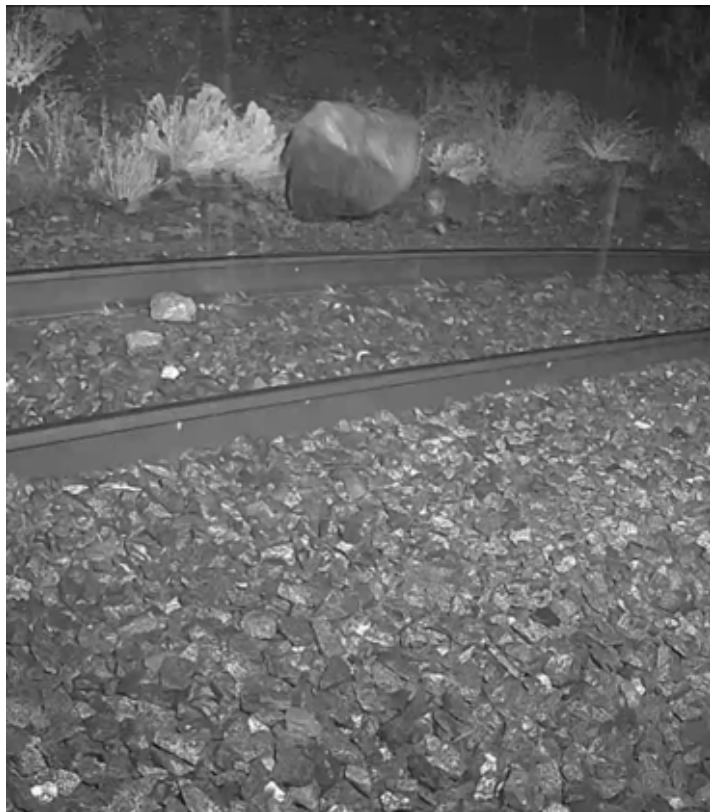
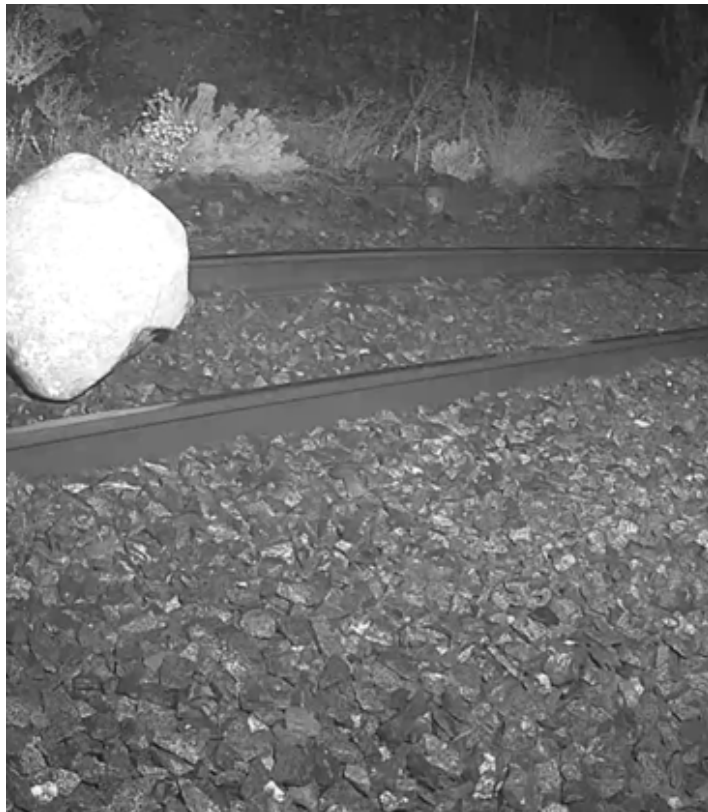
Being of well above the minimum size that the rockfall system is set to alarm upon (Greater than 16X16), and in the center of the detection zone, Rockfall Monitoring went into alarm. This alarm set the local relay from clear to obstructed, and sent out an alarm email 45 seconds after the event took place to the customer's personnel. This alert was used to stop local train traffic and send maintainers out to clear the track. This detection was critical in highlighting the dangers of relying on a slide fence, rather than actively monitoring the tracks for obstructions.

A qualifying rock of approximately 36" X 44" fell within the detection zone at 2:50am on September 27th, 2024. Upon video review of the event, this rock bounced through the slide fence wires without tripping the fence. The below image shows the bottom wires, where the rock passed through intact. Furthermore, this missed activation was confirmed by the railroad.

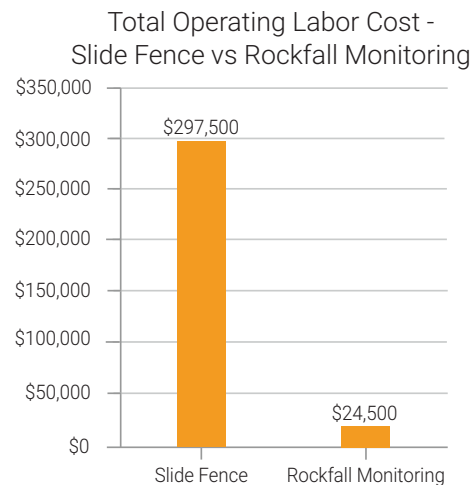
Cost of Slide Fence Activations (Through 2024)

When a rock slide fence is activated, the system remains in alarm until the fence is manually reset or repaired. Due to this, any activation, whether genuine or false-alarm requires a maintenance callout. Rockfall Monitoring on the other hand will automatically reset if an alarming obstacle is removed and is much less prone to false alarm than a slide fence from benign environmental conditions. During the trial period the slide fence required 85 callouts to reset the system. During the same period, Rockfall Monitoring only had 5 events for routine maintenance, and 3 valid obstacles needed to be cleared; a total of 7 callouts. For sake of comparison a callout will be assumed to cost approximately \$3,500, a number determined by a 2018 case study around slide fence maintenance. These operational labor cost comparisons for labor are denoted in the chart above.

Moreover, Rockfall Monitoring delivers substantial operational cost savings. During the trial, the slide fence required 85 maintenance callouts, compared to just 7 for Rockfall Monitoring. With each callout costing an estimated \$3,500, the potential for cost reduction is clear. Additionally, Rockfall Monitoring's lower false alarm rate resulted in significantly less train slow order time—129 fewer hours compared to the slide fence—further boosting operational efficiency and reducing service delays.

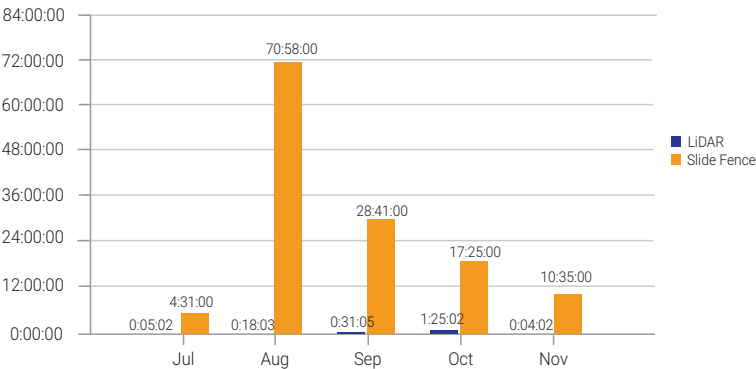
Slow Order Time (HH:MM:SS) by System Type Environmental False Alarms

Environmental conditions cause the slide fence to routinely false alarm. These false alarms still trigger a slow order as trains need to approach the area at caution. Throughout the trial period, environmental conditions leading to false alarms, and slow orders were meticulously tracked. Through July-November, the slide fence caused 131 hours of slow order time at the site. Through this same period, Rockfall Monitoring resulted in 2 hours of slow order time, a 98.5% reduction from the slide fence.
